MATHEWS COUNTY
RURAL DITCH ENHANCEMENT STUDY

Prepared For:
Mathews County Ditching Committee
and
Middle Peninsula Planning District Commission

April 7, 2015

DAA Project Number: B13172B-01

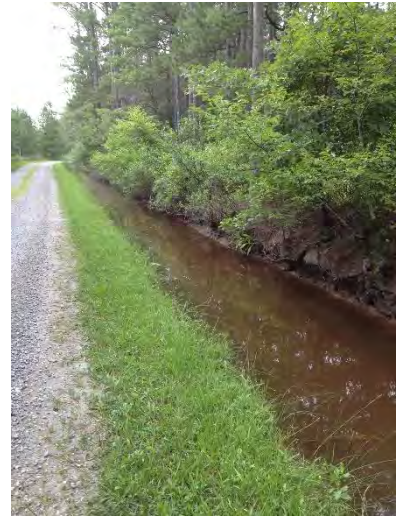
The Diggs study area is along Aarons Beach Road (Route 645) near the intersection with Gullwing Cove Road. Route 645 has well-defined ditches on both sides of the roadway and cross-culverts that ultimately outfall to a Garden Creek tributary; refer to Figure 9 for existing drainage areas and patterns. Significant flooding is reported at the intersection of Route 645 and Gullwing Cove Road.

Photo 1 - Route 645 Roadside Ditch

Site observations on July 16, 2014, indicate VDOT has replaced culverts in this area since the 1980 mapping, as shown in Figure 9. Maintenance of the roadside ditches and culverts does not appear to be a contributing factor to the flooding in this area. Standing water with minimal flow velocity was observed in the roadside and outfall ditches. As per the definitions in Section 2.0, these ditches are open water ditches and are very likely state waters and jurisdictional under Virginia DEQ and U.S. Army Corps of Engineers.

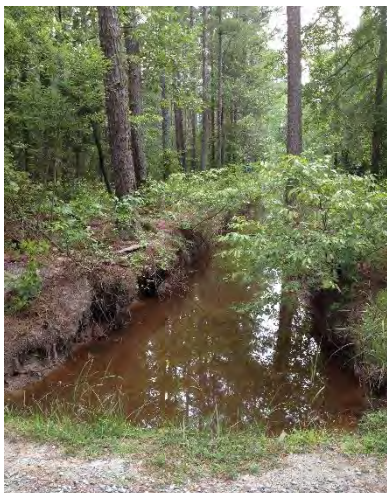
At Gullwing Cove Road, the ditch on the north side of Route 645 from both east and west of the intersection crosses Route 645 and drains south to a ditch on the east side of the road. The ditch from the west on the south side of Route 645 crosses the road via a culvert to the ditch east of the road. The Gullwing Cove Road ditch flows on the east side for approximately 300 feet, then crosses the road via a culvert to the southwest towards the Garden Creek Tributary through the woods to a stream that runs to the marsh, and from the marsh to Garden Creek. As shown in Figure 9, the culverts crossing Route 645 to the ditch east of Gullwing Cove Road are approximately 0.18 feet below the culvert crossing Gullwing Cove Road. The outfall ditch from Gullwing Cove Road is also shown on Cadastral Maps of Mathews County (Section 27) dated June 16, 1982 (Figure 10).

Photo 2 - Route 645 Outfall Ditch

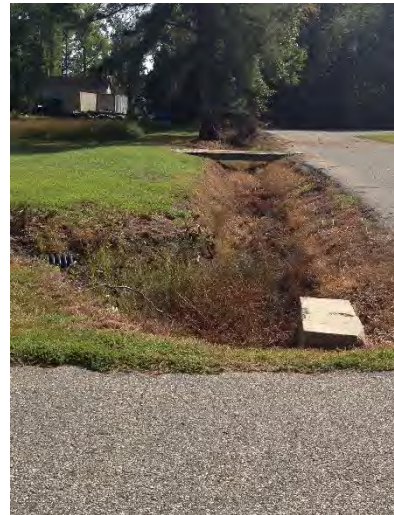
Review of historical aerial photography (2009) indicates a portion of the ditch has been cleared of overgrown vegetation and potentially re-shaped within the past 5 to 10 years. Field observations on September 2, 2014 revealed deceased vegetation within the drainage system both in the ditch along Peachie Lane and east of Peachie Lane on the south side of Route 633; this could be due to long-term standing water following storm events and/or recent maintenance activities to control vegetative growth. Standing water likely evaporates and infiltrates into the soil instead of discharging into a drainage system. The photos included for this area were taken on September 2, 2014 during a dry period in the region.

Photo 3 - Peachie Ln. Ditch Looking South

The ditch along the east side of Peachie Lane should be maintained and reconstructed, specifically the segment from 200 to 1,200 feet south of Route 633, to provide positive drainage toward the outfall ditch; refer to Figure 13. The slope of this ditch will be minimal - approximately 0.3 percent, but provide positive drainage toward Edwards Creek. Additionally, the driveway culvert located approximately 500 feet south of Route 633 should be removed and replaced with two (2) 18-inch culverts placed at elevations to provide positive drainage. Disturbed areas and excavated ditch sections should be seeded with water-tolerant, erosion-resistant grass, such as Bermudagrass or Kentucky bluegrass, and protected by a biodegradable erosion control fabric to provide immediate stabilization of the channel bed and banks.

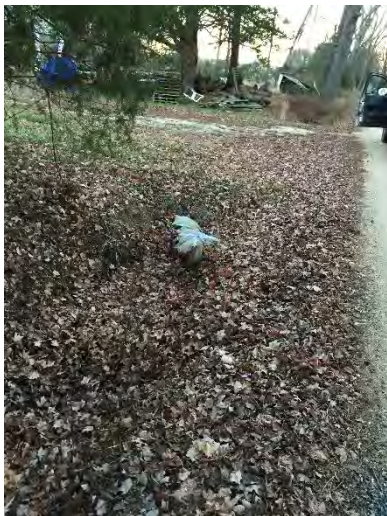
Photo 4 - Collapsed Culvert Along Peachie Lane

Based on site observations on December 11, 2014 and review of 2011 VGIN LIDAR mapping, the ditch line along Peachie Lane has an isolated low point approximately 200 feet south of and a high point, with collapsed culverts, approximately 500 feet south of Route 633.

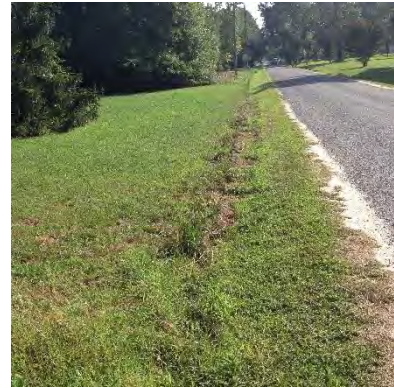
Photo 5 - Bay Haven Road Ditch

Based on site observations and review of historical and current USGS topographic maps and 2011 VGIN LIDAR, ditches exist in these areas, but have minimal slopes and are blocked with

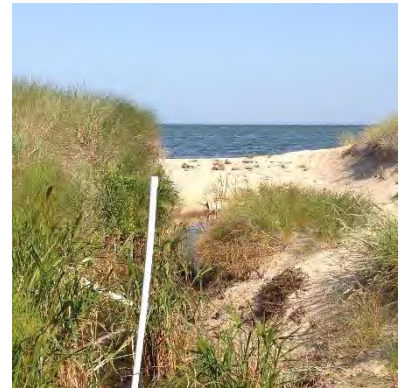
Photo 6 - Existing N. Bay Haven Rd. Outfall at Bay

Alternatively, to lessen the impacts of northeast storms, the roadside ditches from approximately 300 feet north of Duck Pond Lane south to Route 633 (ditch 3B2) could be regraded to drain south towards Edwards Creek. The capacity of the downstream ditches would need to be evaluated to determine whether this is a viable alternative. Regardless, the roadside and outfall ditches 3B1 and 3B3 need to be regraded and frequently inspected and maintained, particularly the opening to the Bay.

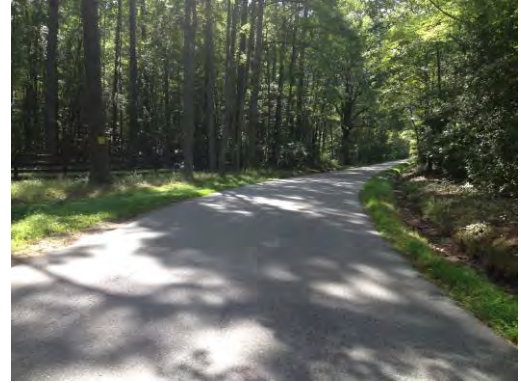
Photo 7 - Route 620 Looking West

Well-defined ditches along the north of Route 620 discharge through a 15-inch culvert crossing the road to

the southeast corner of the intersection (refer to Figure 16). Based on site observations on September 2, 2014, the ditch south of Route 620 parallel to the private drive becomes undefined and the elevations appear to rise resulting in an inadequate outfall from Route 620.

To alleviate the flooding at this location, a ditch should be constructed along the west side of the private drive and south of the Route 620, as per original conditions, to allow runoff to flow south toward the North River; refer to Figure 16. This ditch will be approximately 2,600 feet; the resultant slope of this ditch should be approximately 0.1 percent, but should provide positive drainage toward the river. The ditch and adjacent disturbed areas should be seeded with water-tolerant, erosion-resistant grass, such as Bermudagrass or Kentucky bluegrass, and should be protected by a biodegradable erosion control fabric to provide immediate stabilization of the channel bed and banks. A drainage easement and/or land acquisition will be required to complete this work.

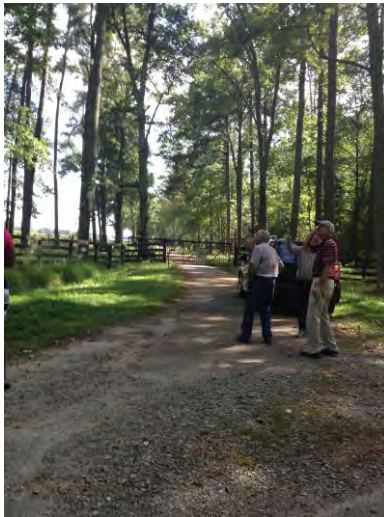
Photo 8 – Private Drive Looking South

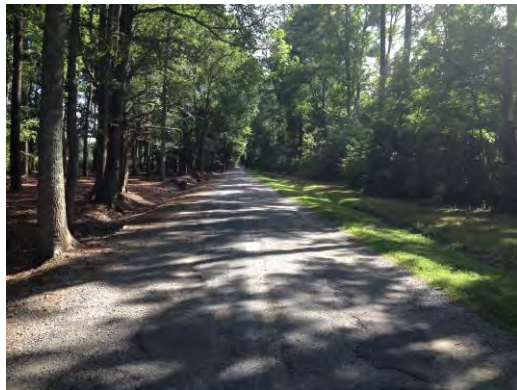
Photo 10 – Old Auburn Road

little topographic relief with an elevation of approximately 8 feet; refer to Figure 16. Flooding in this area appears to result from both the lack of topographic relief and inadequate outfalls.
